Ambient Groundwater Quality of the Douglas Basin: An ADEQ 1995-1996 Baseline Study

---Douglas C. Towne
Maps by Larry W. Stephenson
ADEQ Fact Sheet 00-08
September 2000

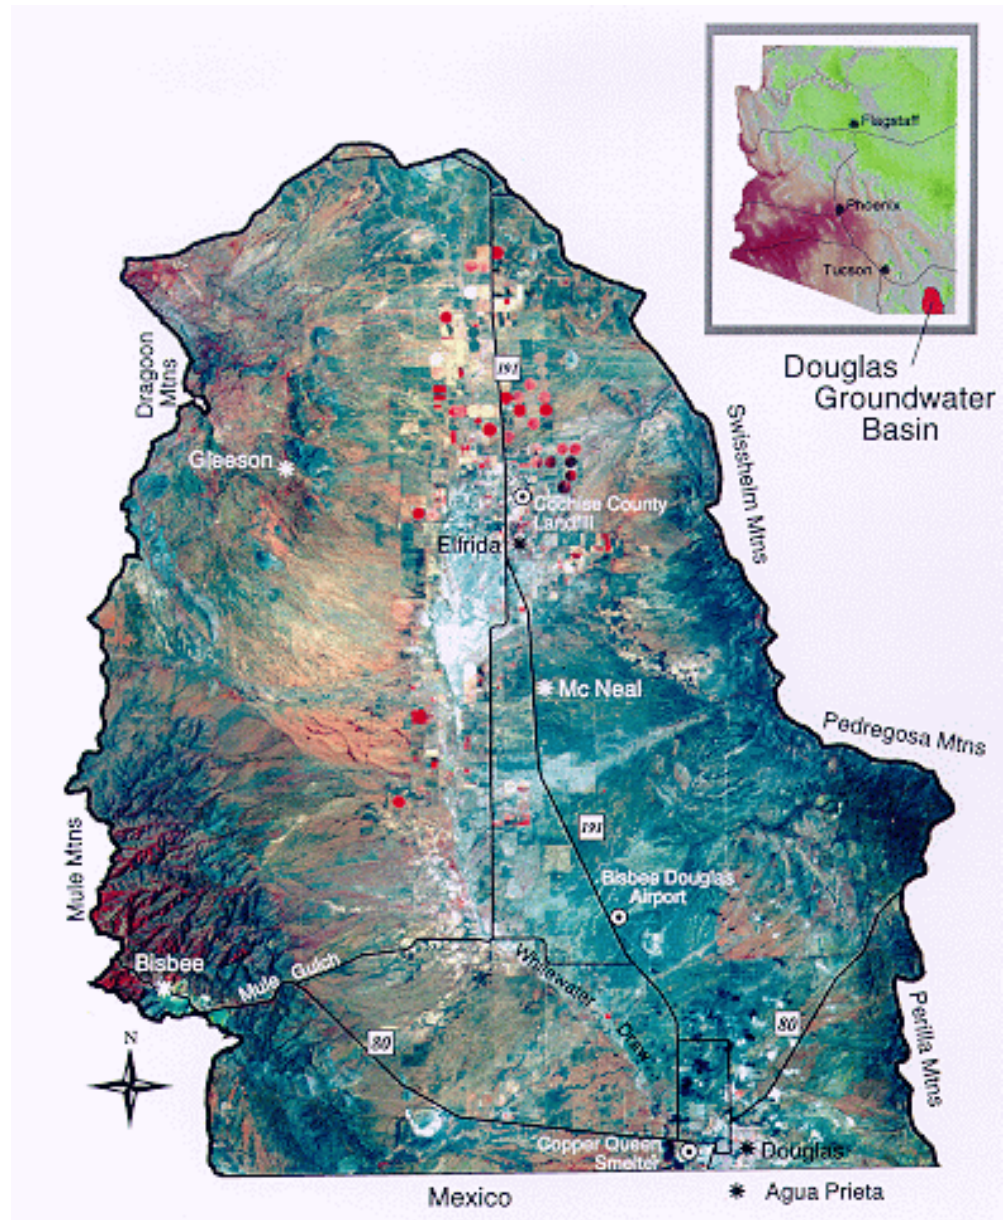
Figure 1. Infrared satellite image of the Douglas Groundwater Basin (DGB) taken in June, 1993. Irrigated farmland is shown in bright red in the central parts of the basin, grasslands and mountain areas appear in both blue and brown. The inset map shows the location of the DGB within Arizona.

The Douglas Groundwater Basin (DGB) is located in southeastern Arizona (**Figure 1**). It is a picturesque broad alluvial valley surrounded by rugged mountain ranges. This factsheet is based on a study conducted in 1995-1996 by the Arizona Department of Environmental Quality (ADEQ) and summarizes a comprehensive regional groundwater quality report (1).

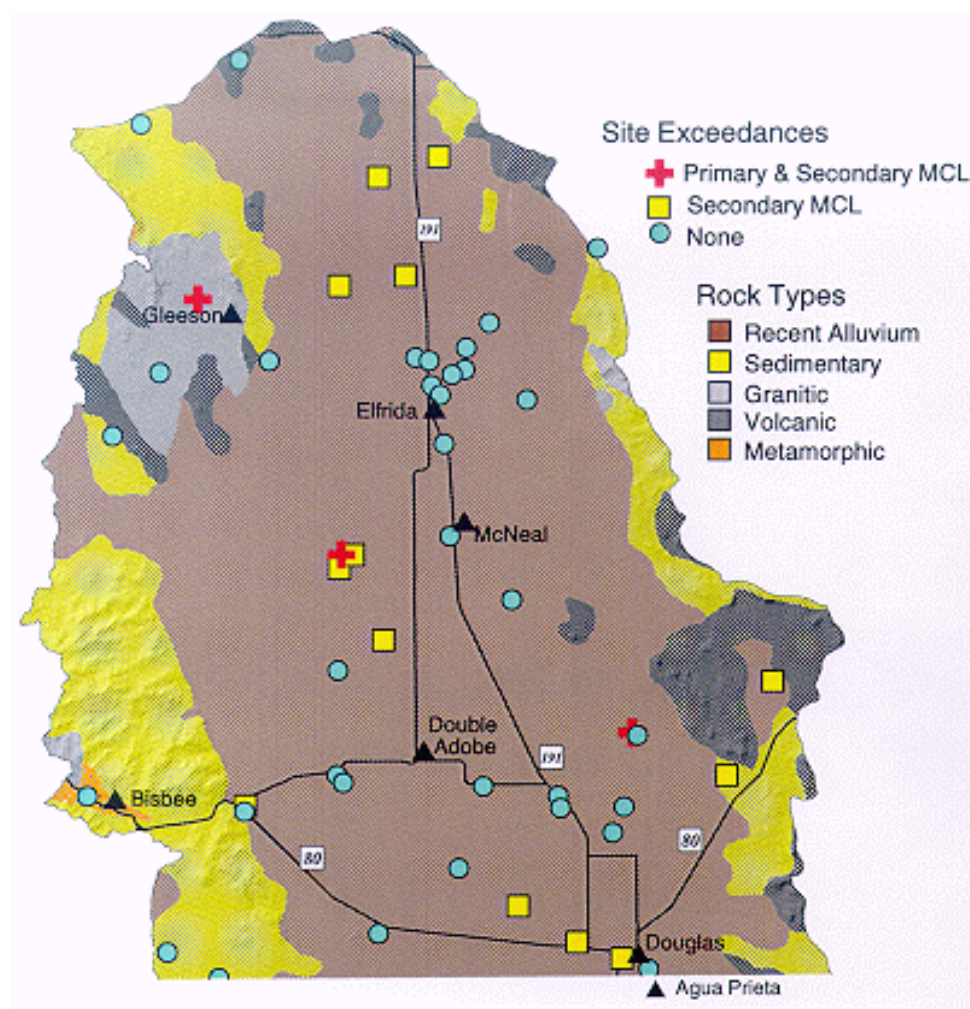
Figure 3. Locations of 51 sample sites, including 3 sites exceeding health-based water quality standards and 16 sites exceeding aesthetics-based water quality guidelines, are shown in this map.

The collected groundwater quality data were compared with U.S. Environmental Protection Agency (USEPA) Safe Drinking Water quality standards. Primary Maximum Contaminant Levels (MCLs) are enforceable, health-based water quality standards that public systems must meet when supplying water to their customers. Primary MCLs are based on a lifetime daily consumption of two liters of water. Three of the 51 sites sampled had parameter levels exceeding a Primary MCL: arsenic, beryllium, and nitrate each exceeded their respective Primary MCLs at one site each (**Figure 3**).

cosmetic or laundry effects, but is not considered a health concern. Sixteen of the 51 sites sampled had parameters exceeding a Secondary MCL (**Figure 3**). Exceedances included fluoride and total dissolved solids (TDS) (eight sites each), pH and sulfate (two sites each), and chloride, iron, and manganese (one site each).

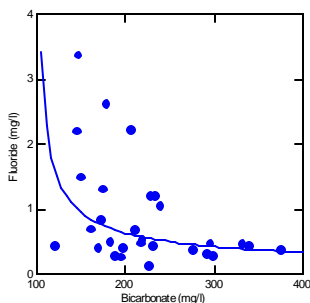
Figure 4. Fluoride levels generally decrease with increasing bicarbonate levels (Pearson Correlation Coefficient test, $p \# 0.05$).

The association between levels of different parameters was examined. Fluoride was positively correlated with pH and negatively correlated with bicarbonate (**Figure 4**) and calcium (Pearson Correlation Coefficient test, $p \# 0.05$). Calcium is an important

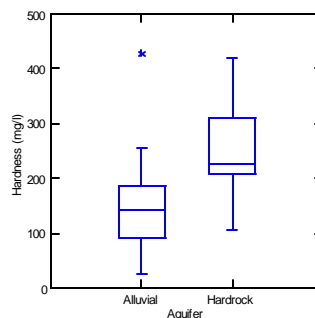
Figure 5. Hardness levels are higher in the hardrock aquifer than in the alluvial aquifer (Kruskal-Wallis, $p \# 0.05$).

Levels of bicarbonate, calcium, hardness (**Figure 5**), magnesium, sulfate, and turbidity were significantly higher in the hardrock aquifer than the alluvial aquifer. The opposite trend occurred with temperature and pH (Kruskal-Wallis test, $p \# 0.05$).

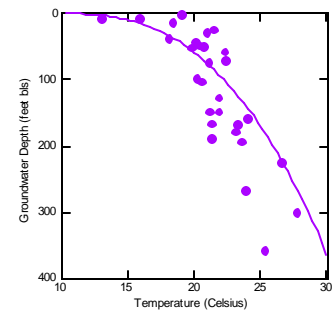
Figure 6. Temperature generally increases with increasing groundwater depth below land surface (regression analysis, $p \# 0.01$).

Levels of calcium, hardness, specific conductivity, sulfate, and turbidity significantly decreased with increasing groundwater depth below land surface (bls). In contrast, boron, potassium, pH, and temperature (**Figure 6**) increased with increasing groundwater depth bls (regression analysis, $p \# 0.05$).

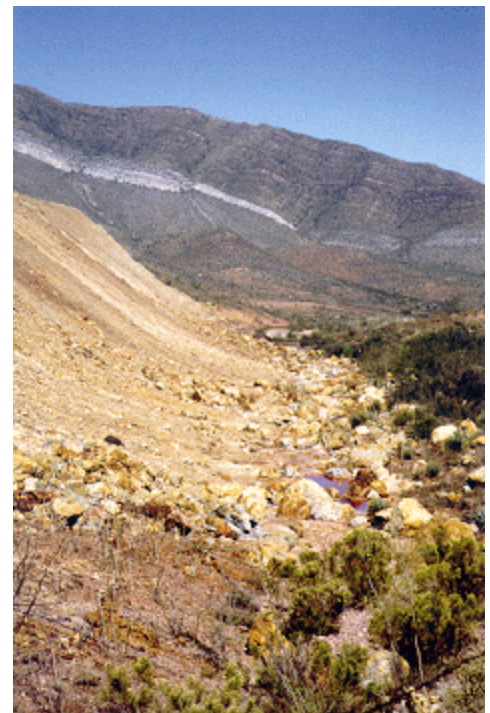
Figure 7. Mine tailings near Mule Gulch appear to contribute to the elevated sulfate levels found downgradient of Bisbee.

Mine tailings appear to be contributing to elevated groundwater sulfate levels found along Mule Gulch, downgradient of the town of Bisbee (**Figure 7**). Sulfides in these tailings are oxidized to yield sulfate that is soluble in water. A site near where Mule Gulch enters the alluvium of Sulphur Springs Valley had a sulfate level of 1330 mg/l, exceeding the 250 mg/l Secondary MCL. Further downgradient, sulfate levels rapidly decreased. Elevated sulfate levels due to mine activities have been found south of Bisbee near the town of Naco (4).

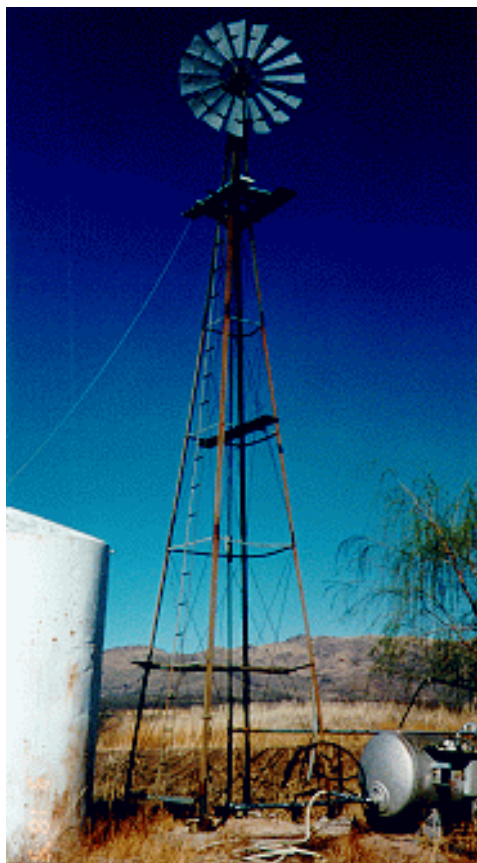
Figure 8. Windmill pumps water into a storage tank by the Pedregosa Mountains.

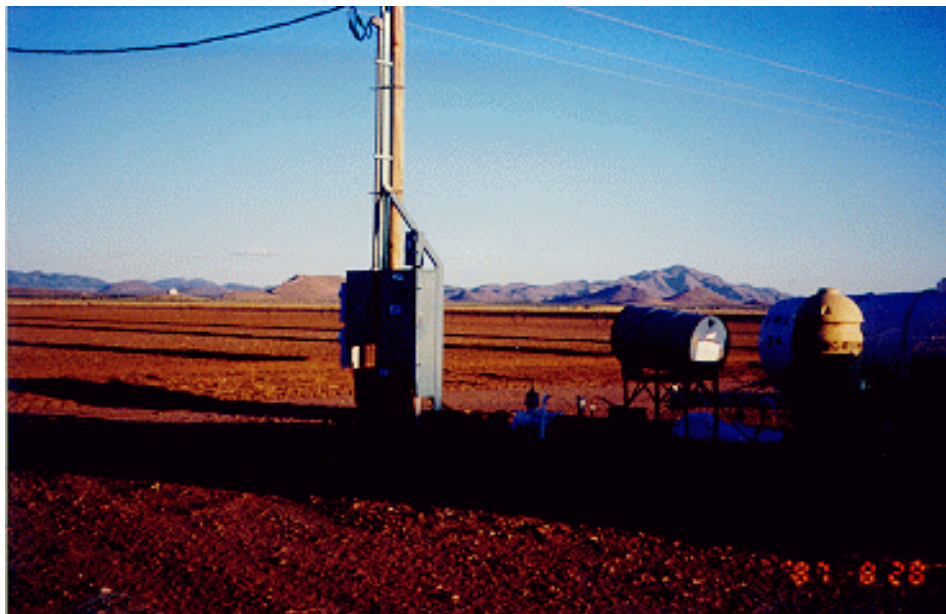
Figure 9. Farmland, irrigated by groundwater pumped by the turbine well in the foreground, lies fallow after fall harvest north of the town of Elfrida.

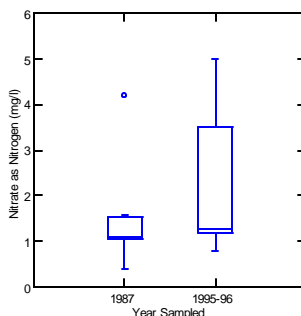
Figure 10. Nitrate levels in 1995-1996 were higher than in 1987 (Wilcoxon test, $p \neq 0.05$).

Department of Water Resources, were resampled by ADEQ for this study (2). While many of the 12 parameters examined appear to have higher levels in 1995-1996 than in 1987, only nitrate (**Figure 10**) and potassium levels were significantly higher (Wilcoxon ranked-sum test, $p \neq 0.05$).
